SUBJECT: Report of Investigation of Violent Chemical
Reaction in F₂ Surge Drum, X-344, on March 4, 1959.

REPORT OF INVESTIGATION OF VIOLENT CHEMICAL REACTION

IN F₂ SURGE DRUM, X-344 ON MARCH 4, 1959.

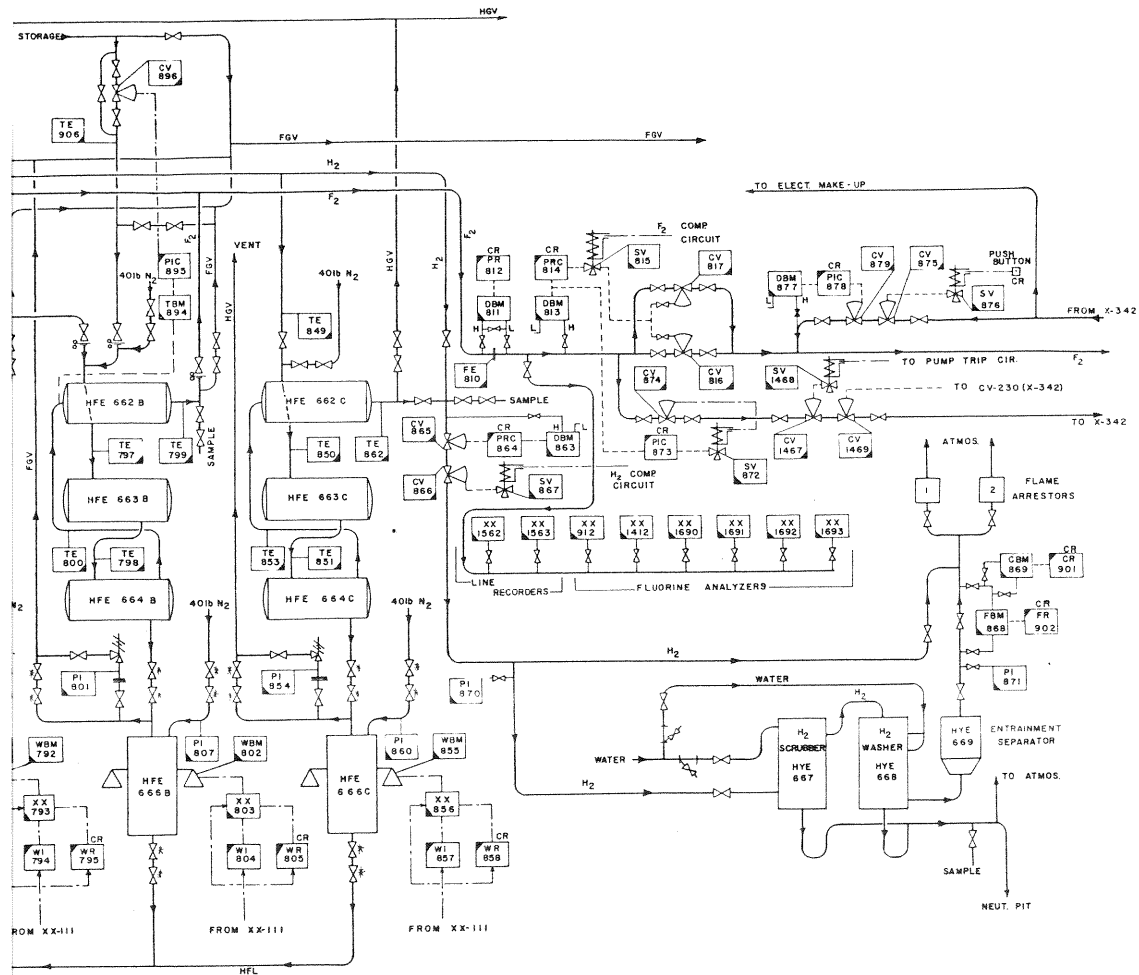
b) At about 0105 other Freon tubes in HFE 663A, heated nearly to the melting point by the fire in the condenser shell, ruptured. This flooded the condenser system with liquid Freon, which flashed to vapor at an initially semi-explosive rate as it struck several square feet of semi-molten metal, producing a pressure surge which shut off the plant through the "Q" circuit. At this time, the HF run-down tank, HFE 666A, flooded with liquid Freon.

Fig. No. 9 "Melted tube spacers and ruptured tubes in gas cooler HFE663A."
